Learning Brief

Silo Structural Failure and Collapse

Hinkley Point C

SELMA no.: SAEI-41324

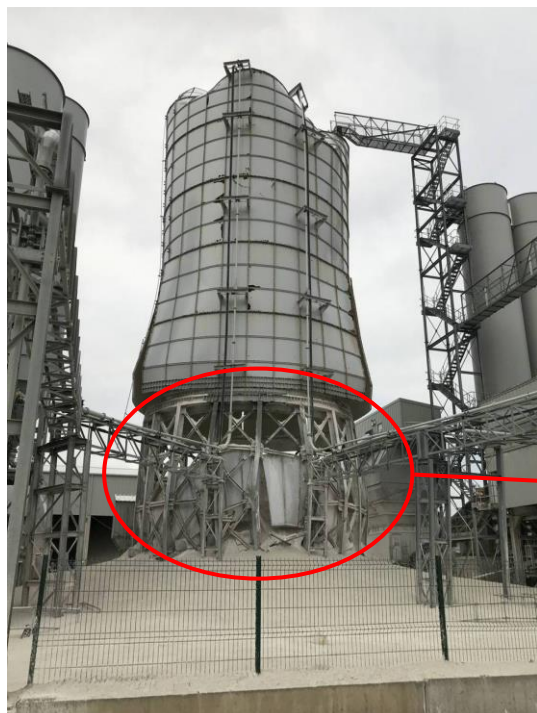
At 07:04 on 10th June 2020 at the Hinkley Point C (HPC) construction site, a 5,000-tonne silo containing GGBS for use in making concrete collapsed suddenly and without warning. Nobody was injured in this event, the silo being in a dormant state at the time, with operations scheduled to begin at around 07:30 on the day.

- Collapse of the silo occurred by mechanical overload (structural failure), most likely of a vertically aligned bolted joint in the cone section. Damage to the cylinder section of the silo was considered to be consequential damage, caused by the rapidly descending material which resulted in vacuum collapse of the roof and a related overload of the lower cylinder section.

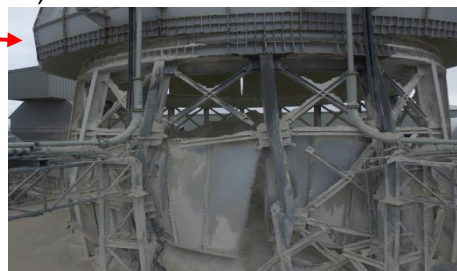
The silo was erected in June 2018 as a temporary works structure used in construction and was not a permanent part of the power station. The silo was of a bolted design with welded flanges, as opposed to lap joints. The main cylinder was installed in five ring sections, each three panels in height (28 individual panels per ring). The cone/hopper section was manufactured in three sections; a transition section (18 panels) and upper cone/lower cone sections (36 panels each).

The panels were specified as 15 mm thick for the cone and lowest cylinder ring section and 10 mm thick for the remaining four uppermost cylinder ring sections. The panel flanges were made with a 6mm throat thickness single-sided fillet weld on the outside of the panels. No welds were specified on the inside of the panels. M18 gr8.8 structural bolts joined the cone and cylinder panel flanges together.

- The cause of the mechanical overload was considered to be directly related to an inadequate design of the silo, particularly in relation to the bolted joints.

- The silo design lacked staggered joints that may have limited the spread of damage or collapse from foreseen or unforeseen loads and improved the structural robustness of the design.

- Consider reducing the fill level of the silo regardless of whether the silo has been operated at full, or near full, conditions for an extended period.
The maximum fill level should ensure bolt loads are below the allowable design strength with an appropriate margin of safety.

- Review design calculation dossiers to ensure adequate margins of safety, especially in bolt calculations.
The design load envelope and structural strength assessment techniques should be understood, cover variations in the stored material characteristics and accurately predict the structural behaviour, with supporting validation.

- Identify if the silo joints are potentially susceptible to progressive failure.
A silo incorporating design features, such as vertically staggered joints, provides increased robustness that may halt progressive damage or collapse, adding margins of safety.
