Organisational Learning New Nuclear Build

Silo Structural Failure and Collapse

Hinkley Point C

SELMA no.: SAEI-41324

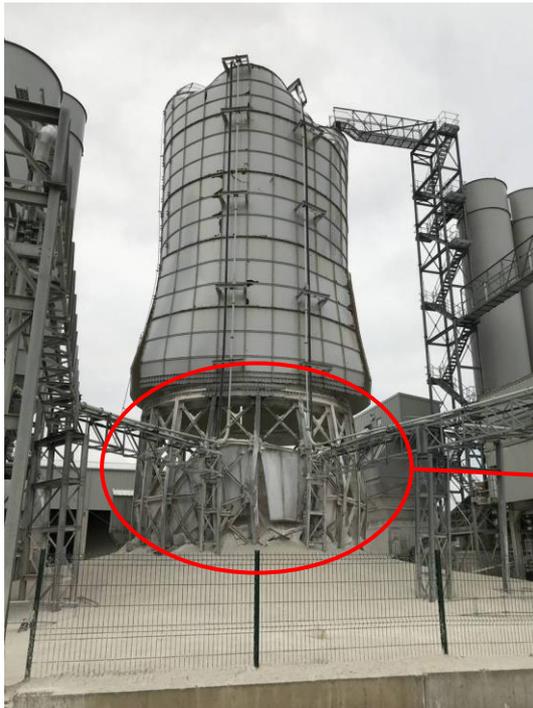
At 07:04 on 10th June 2020 at the Hinkley Point C (HPC) construction site, a 5,000-tonne silo containing GGBS for use in making concrete collapsed suddenly and without warning. Nobody was injured in this event, the silo being in a dormant state at the time, with operations scheduled to begin at around 07:30 on the day.

- Collapse of the silo occurred by mechanical overload (structural failure), most likely of a vertically aligned bolted joint in the cone section. Damage to the cylinder section of the silo was considered to be consequential damage, caused by the rapidly descending material which resulted in vacuum collapse of the roof and a related overload of the lower cylinder section.

- The cause of the mechanical overload was considered to be directly related to an inadequate design of the silo, particularly in relation to the bolted joints.

- Changes in temperature (differential thermal ratchetting or racking effects) over the preceding days is considered to have generated an increase in load on the silo that directly contributed to the failure.

- Consider reducing the fill level of the silo regardless of whether the silo has been operated at full, or near full, conditions for an extended period.
The maximum fill level should ensure bolt loads are below the allowable design strength with an appropriate margin of safety.

- Review design calculation dossiers to ensure adequate margins of safety, especially in bolt calculations.
The design load envelope and structural strength assessment techniques should be understood, cover variations in the stored material characteristics and accurately predict the structural behaviour, with supporting validation.

- Identify if the silo joints are potentially susceptible to progressive failure.
A silo incorporating design features, such as vertically staggered joints, provides increased robustness that may halt progressive damage or collapse, adding margins of safety.

- Check the structural bolts supplied comply with standard requirements.
Independent verification should always be considered of the test results and material analysis from the manufacturer to ensure the bolts match the certification supplied with each batch, especially if close to lower limits.

- Carry out a visual inspection of the silo to identify any areas of concern.
Dust emissions could suggest a poorly tightened or strained joint.

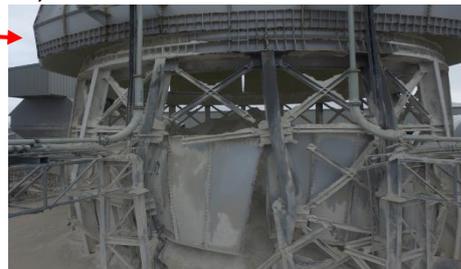
The silo was erected in June 2018 as a temporary works structure used in construction and was not a permanent part of the power station. The silo was of a bolted design with welded flanges, as opposed to lap joints. The main cylinder was installed in five ring sections, each three panels in height (28 individual panels per ring). The cone/hopper section was manufactured in three sections; a transition section (18 panels) and upper cone/lower cone sections (36 panels each).

The panels were specified as 15 mm thick for the cone and lowest cylinder ring section and 10 mm thick for the remaining four uppermost cylinder ring sections. The panel flanges were made with a 6mm throat thickness single-sided fillet weld on the outside of the panels. No welds were specified on the inside of the panels. M18 gr8.8 structural bolts joined the cone and cylinder panel flanges together.

- The silo design lacked staggered joints that may have limited the spread of damage or collapse from foreseen or unforeseen loads and improved the structural robustness of the design.

- The degree of variation in the mechanical properties of the structural bolts could mean that a significant number of bolts may not have met the specified minimum strength grade requirement.
